**City of Mesquite Convention Center  
Additional Due Diligence Field Verification of Scan Results 12-8-23**

**12-8-2023 BUR Roof Sections Mesquite Convention Center IR Scan - Field Verification & Due Diligence**

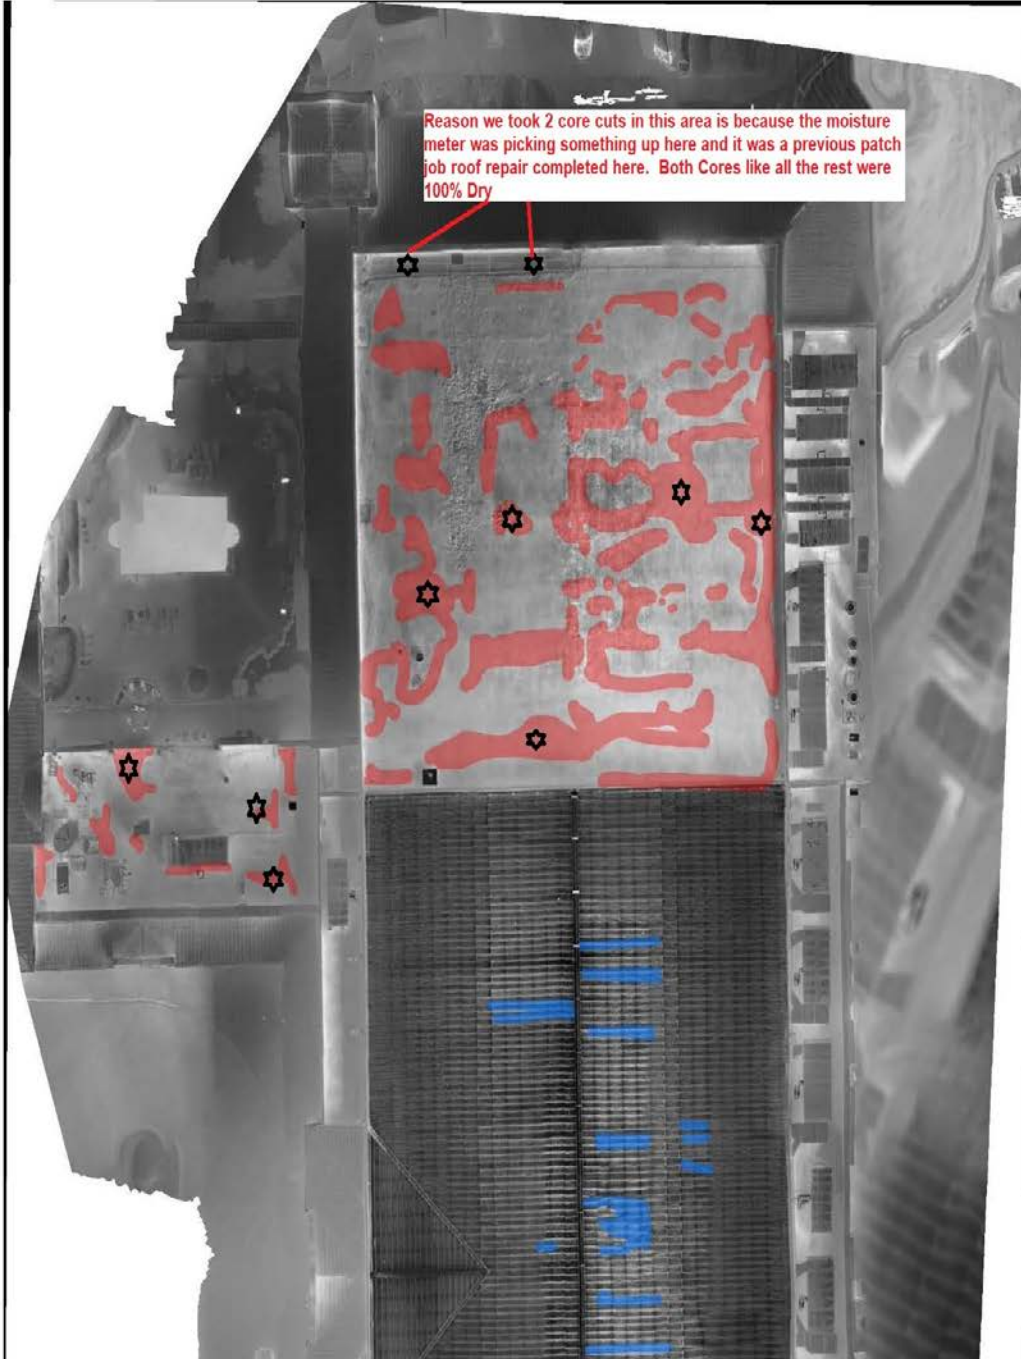
## FIELD VERIFICATION & CORE SAMPLE MAP

★ Core Cuts Taken with all 100% Dry Results

We pretty much walked the roof and tested with the moisture meter all of the red areas and many other random areas on the roof. The only place we picked up any reading of moisture was identified above where the roof patch job was made and core samples were 100% dry.

As a roofing professional for over 25 years here in DFW and millions of square feet of roof restoration and replacement solutions, this is a perfect candidate for Roof Restoration.

Once we start the restoration and get the gravel off, it is possible we run into some small areas that have moisture, but those can be easily addressed and is why we put a contingency in our proposal to address unforeseen issues that arise.

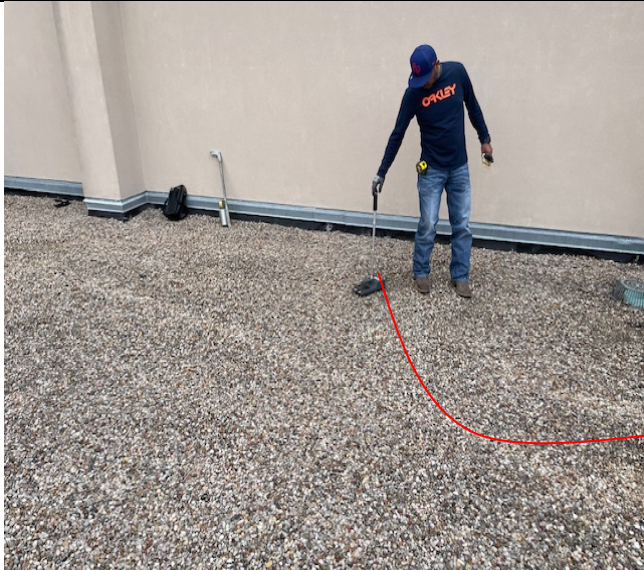
## Small Roof By Roof Hatch:

We tested many random areas on this roof with our Tramex Moisture Meter and no signs of moisture as seen in the next photo.

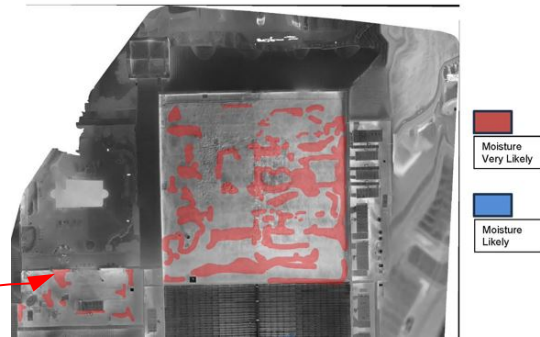
Map from IR Scan and area tested

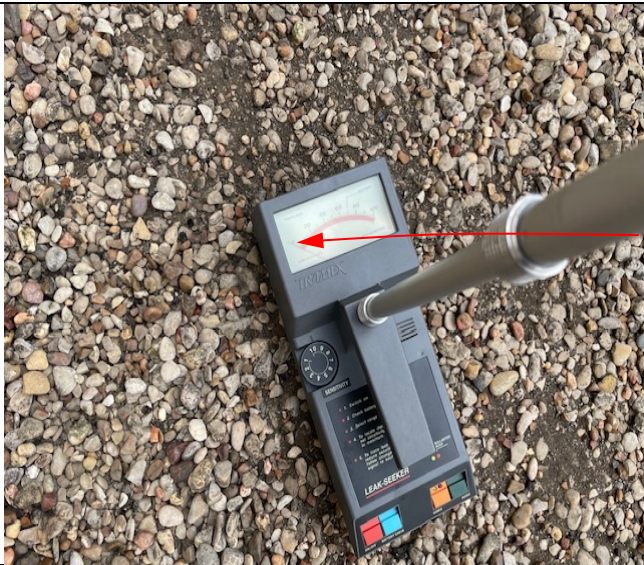
## Tramex Moisture Meter:

This is an up close showing no reading of moisture.

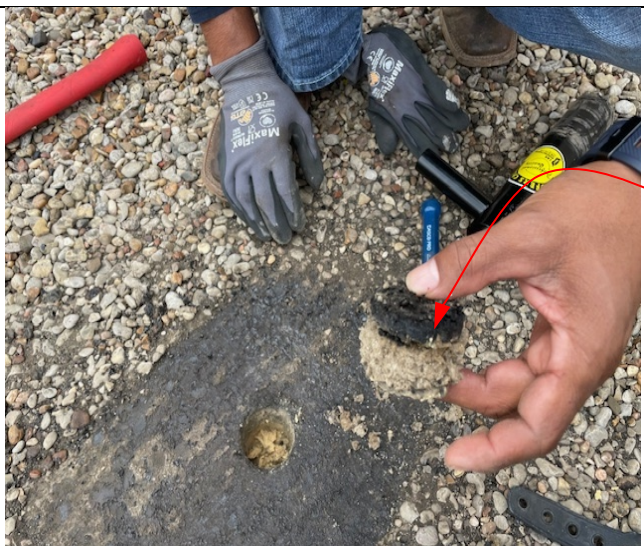
## Core Sample taken from Field Verification:

Here you can see the core sample taken in the area above showing no signs of moisture and a very solid BUR Roof membrane that is still intact, solid, monolithic, and strong, making it a perfect candidate to capture the remaining value in this roof through Roof Restoration.

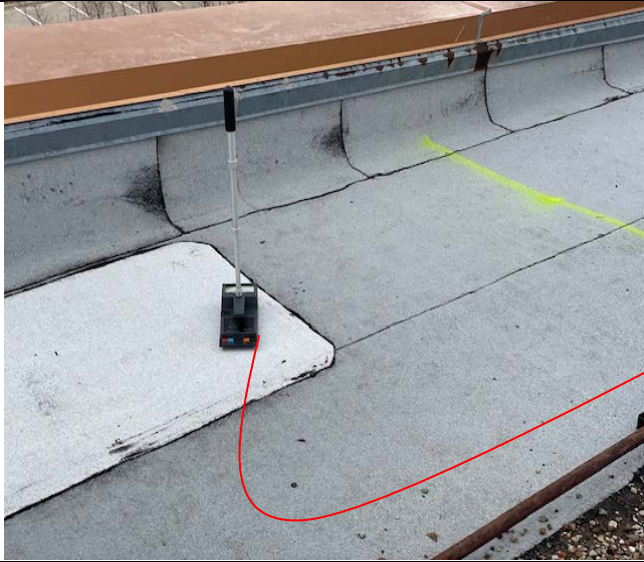
**Upper Roof Where Patch Job Completed:**  
This was the only area that picked up any signs of moisture. We took 2 core samples here and both were 100% dry.

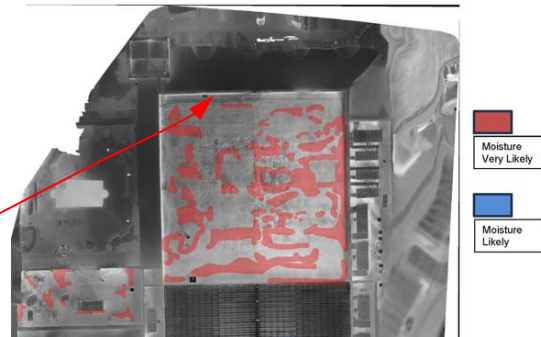
Map from IR Scan and area tested

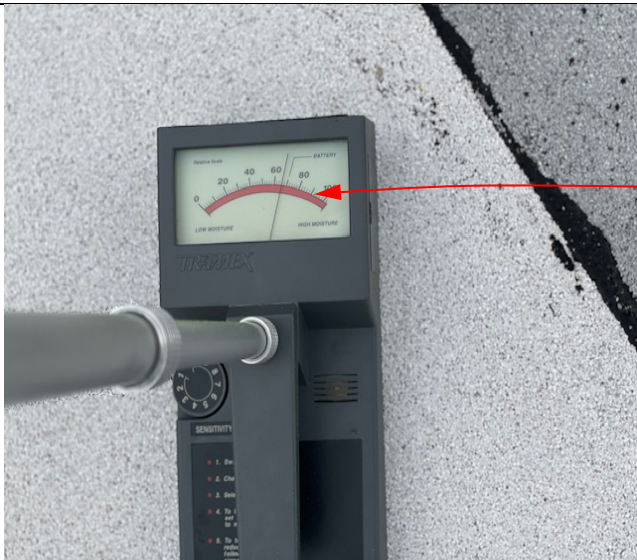
**Tramex Moisture Meter:**  
This is an up close showing some reading of moisture where a patch job has been applied recently.

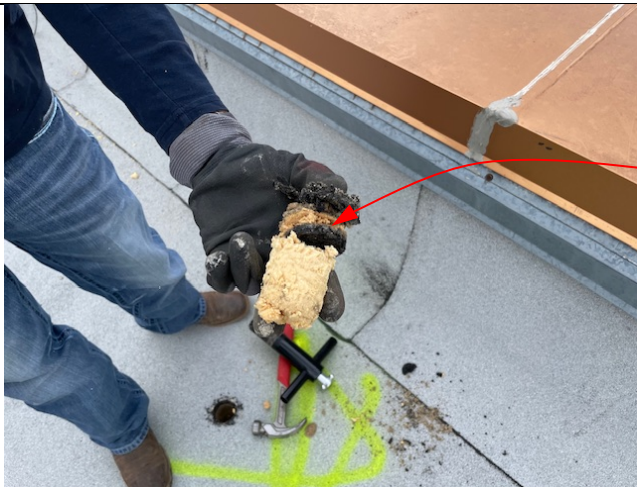
**Core Sample taken from Field Verification:**  
Here you can see the core sample taken in the area above showing no signs of moisture and a very solid BUR Roof membrane that is still intact, solid, monolithic, and strong, making it a perfect candidate to capture the remaining value in this roof through Roof Restoration. We actually took 2 cores in this area mainly because we were picking up a reading on the Moisture Meter and plus the roof had been recently patched in this area.

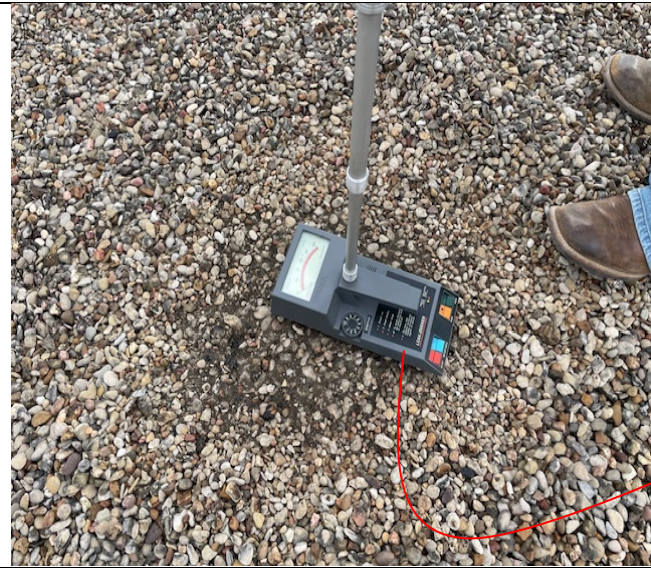
## Upper Roof BUR Area:

We tested many random areas on this roof with our Tramex Moisture Meter and no signs of moisture as seen in the next photo.

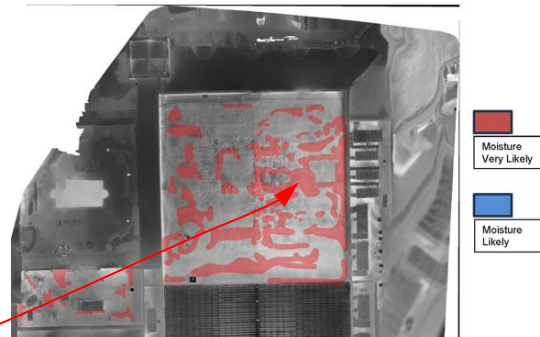
Map from IR Scan and area tested

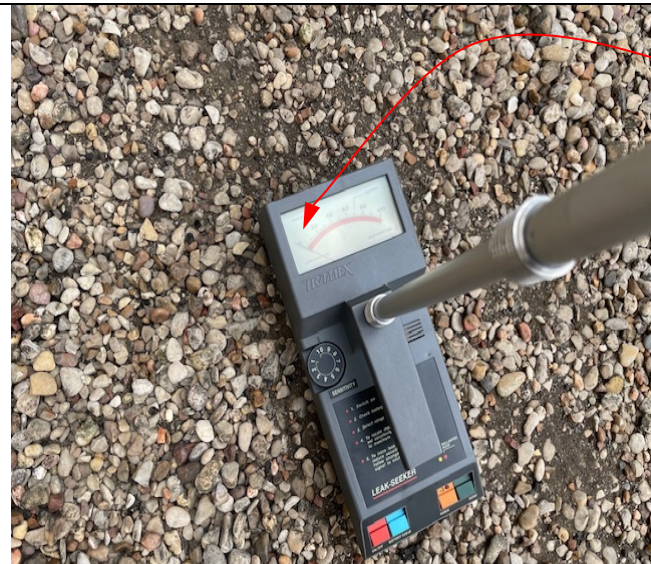
## Tramex Moisture Meter:

This is an up close showing no reading of moisture.

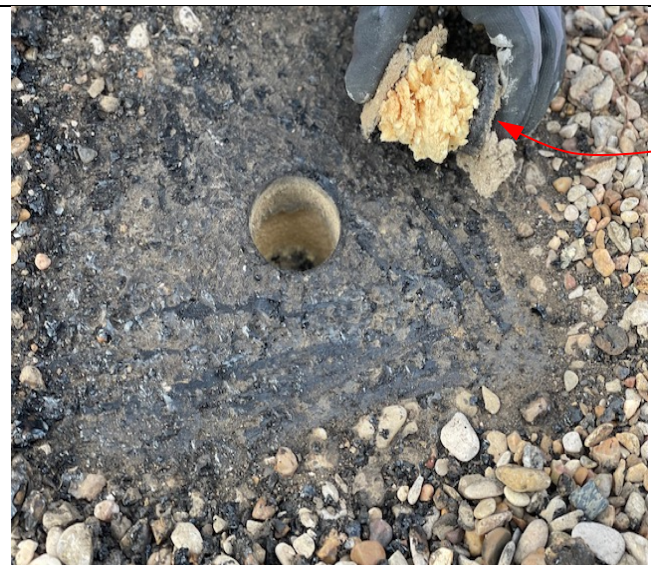
## Core Sample taken from Field Verification:

Here you can see the core sample taken in the area above showing no signs of moisture and a very solid BUR Roof membrane that is still intact, solid, monolithic, and strong, making it a perfect candidate to capture the remaining value in this roof through Roof Restoration.
