## Thermal and Visual Roofing Inspection

1700 Rodeo Dr, Mesquite, TX 75149

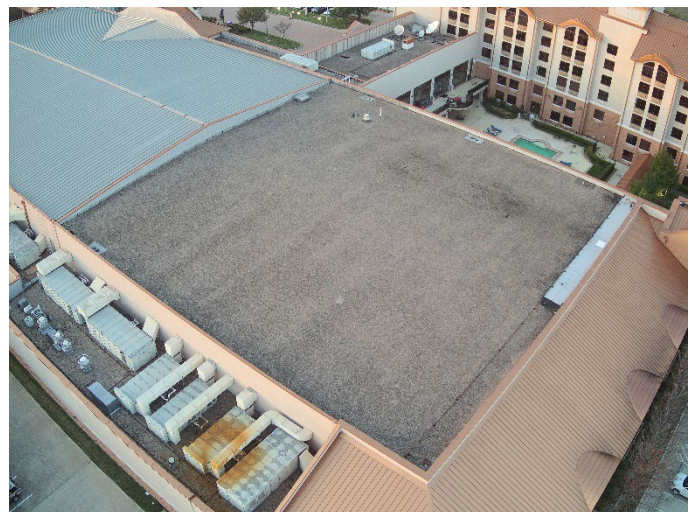
The overall roof of the Mesquite Convention Center appears to be in poor condition. In our professional and unbiased opinion, the roof is retaining abnormal amounts of moisture. This puts the metal structure under the roof in danger of sustaining damage through rust and rot.

We typically see more localized thermal delta which allows for better isolation for repairs rather than replacement. This roof, however, appears to be retaining enough moisture that it is difficult to isolate the areas that would need to be repaired. Often, a roof in this condition would need to be entirely resurfaced or recovered.
